A Case Study

# Paddock Access Route

**Project Details****A paddock access route in voght****Client Details****Private horse owner****Contractor Details****Ecora GmbH, Germany****1000 m<sup>2</sup> EcoGrid laid in no time to the delight of customer and horses!**

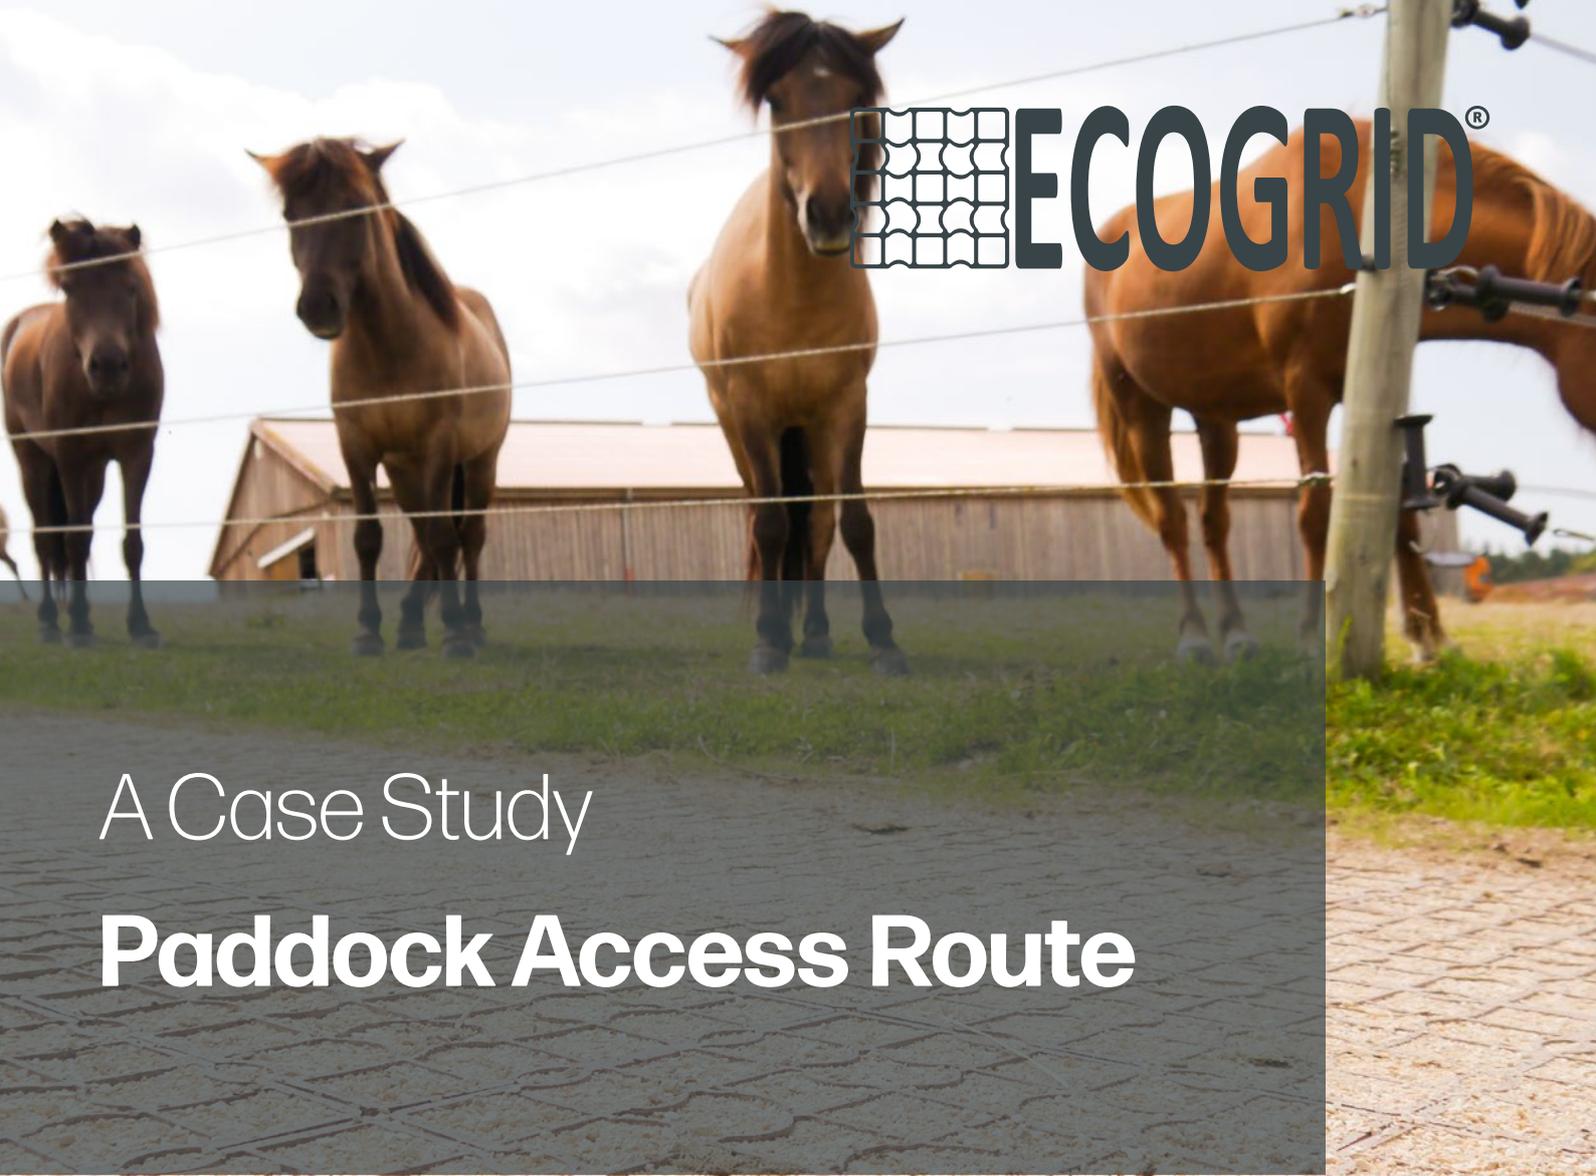
With expert advice from the manufacturer on grid type and substructure, they ultimately decided on the EcoGrid E40, as, with it, a top layer is not absolutely necessary. Work got underway in Autumn 2009: the upper layer on the 1000 m<sup>2</sup> area was removed, and then 15 cm of gravel with grain 0-32 mm without any clay laid on top. Next came installation: the polyethylene elements came pre-assembled, which made it possible to lay 1.3 m<sup>2</sup> at a time. Each section weighed less than 7 kg, so with two men on the job the entire surface was laid in a day, and without scratched hands or sore backs. These were then infilled with coarse sand with grain 0-3 mm and compacted.
